CTION OF A 12-YEAR-OLD GLUED-LAMINATED

STRINGER BRIDGE WITH NAILED-LAMINATED DECK--

DECAY HAZARD ASPECTS

Report to Division of Engineering,
Forest Service

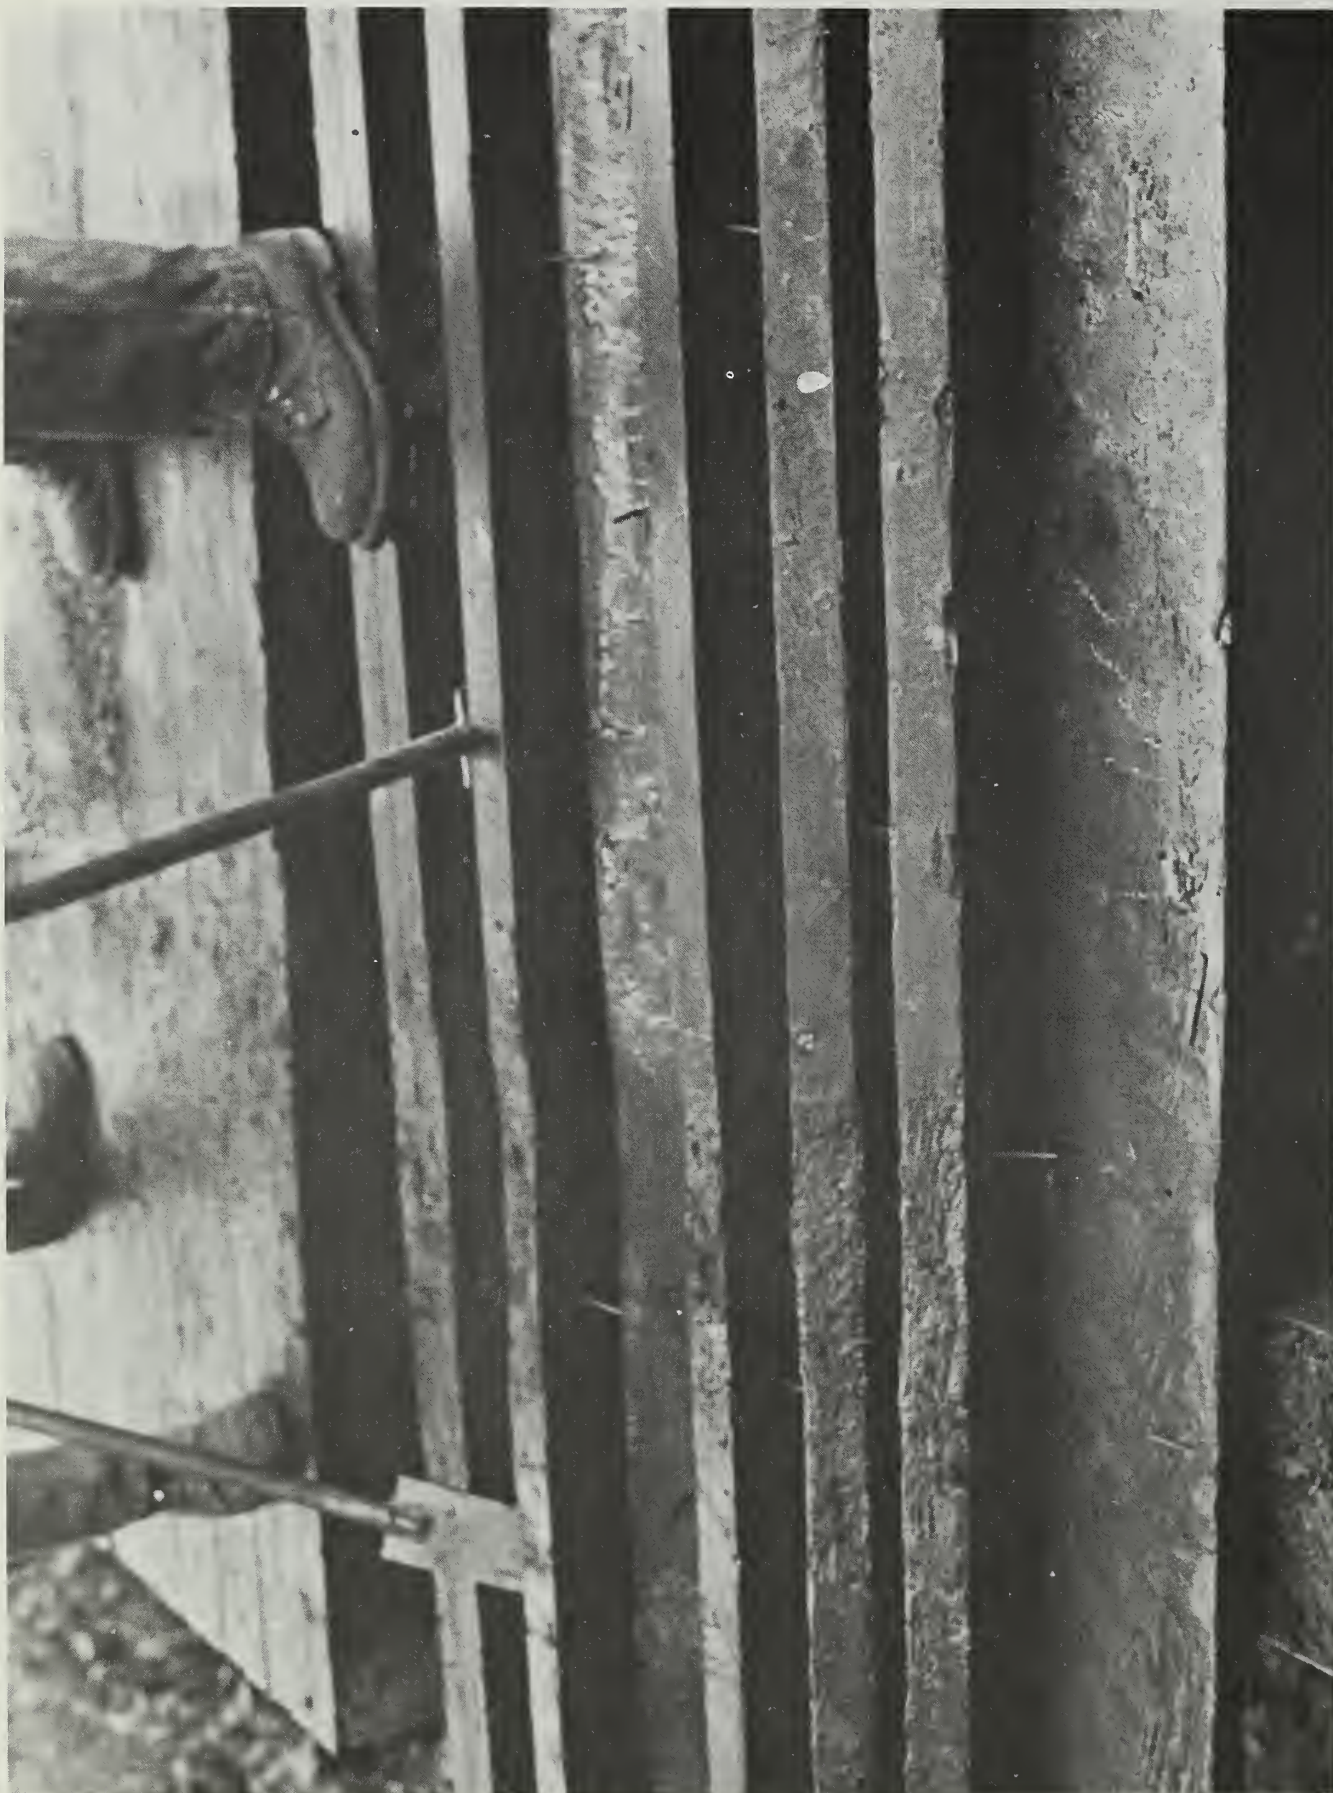
(M 138 111)

The original 12-year-old, nailed-laminated deck was completely removed in the 1969 inspection. Individual laminates were loosened for removal with two heavy spuds (fig. 3). The boards were removed in reverse order from the original installation order, making it possible to observe the decking and deck-nail conditions with minimal disturbance due to the mechanics of the removal process. In no case was evidence observed of nail breakage, either of the through-nailing or toenailing, that was attributable to the deck removal process.

Figure 3.--The removal of decking boards was facilitated by steel spuds. Virtually no damage to either the decking or the nail fasteners resulted from systematically prying loose the individual deck boards.

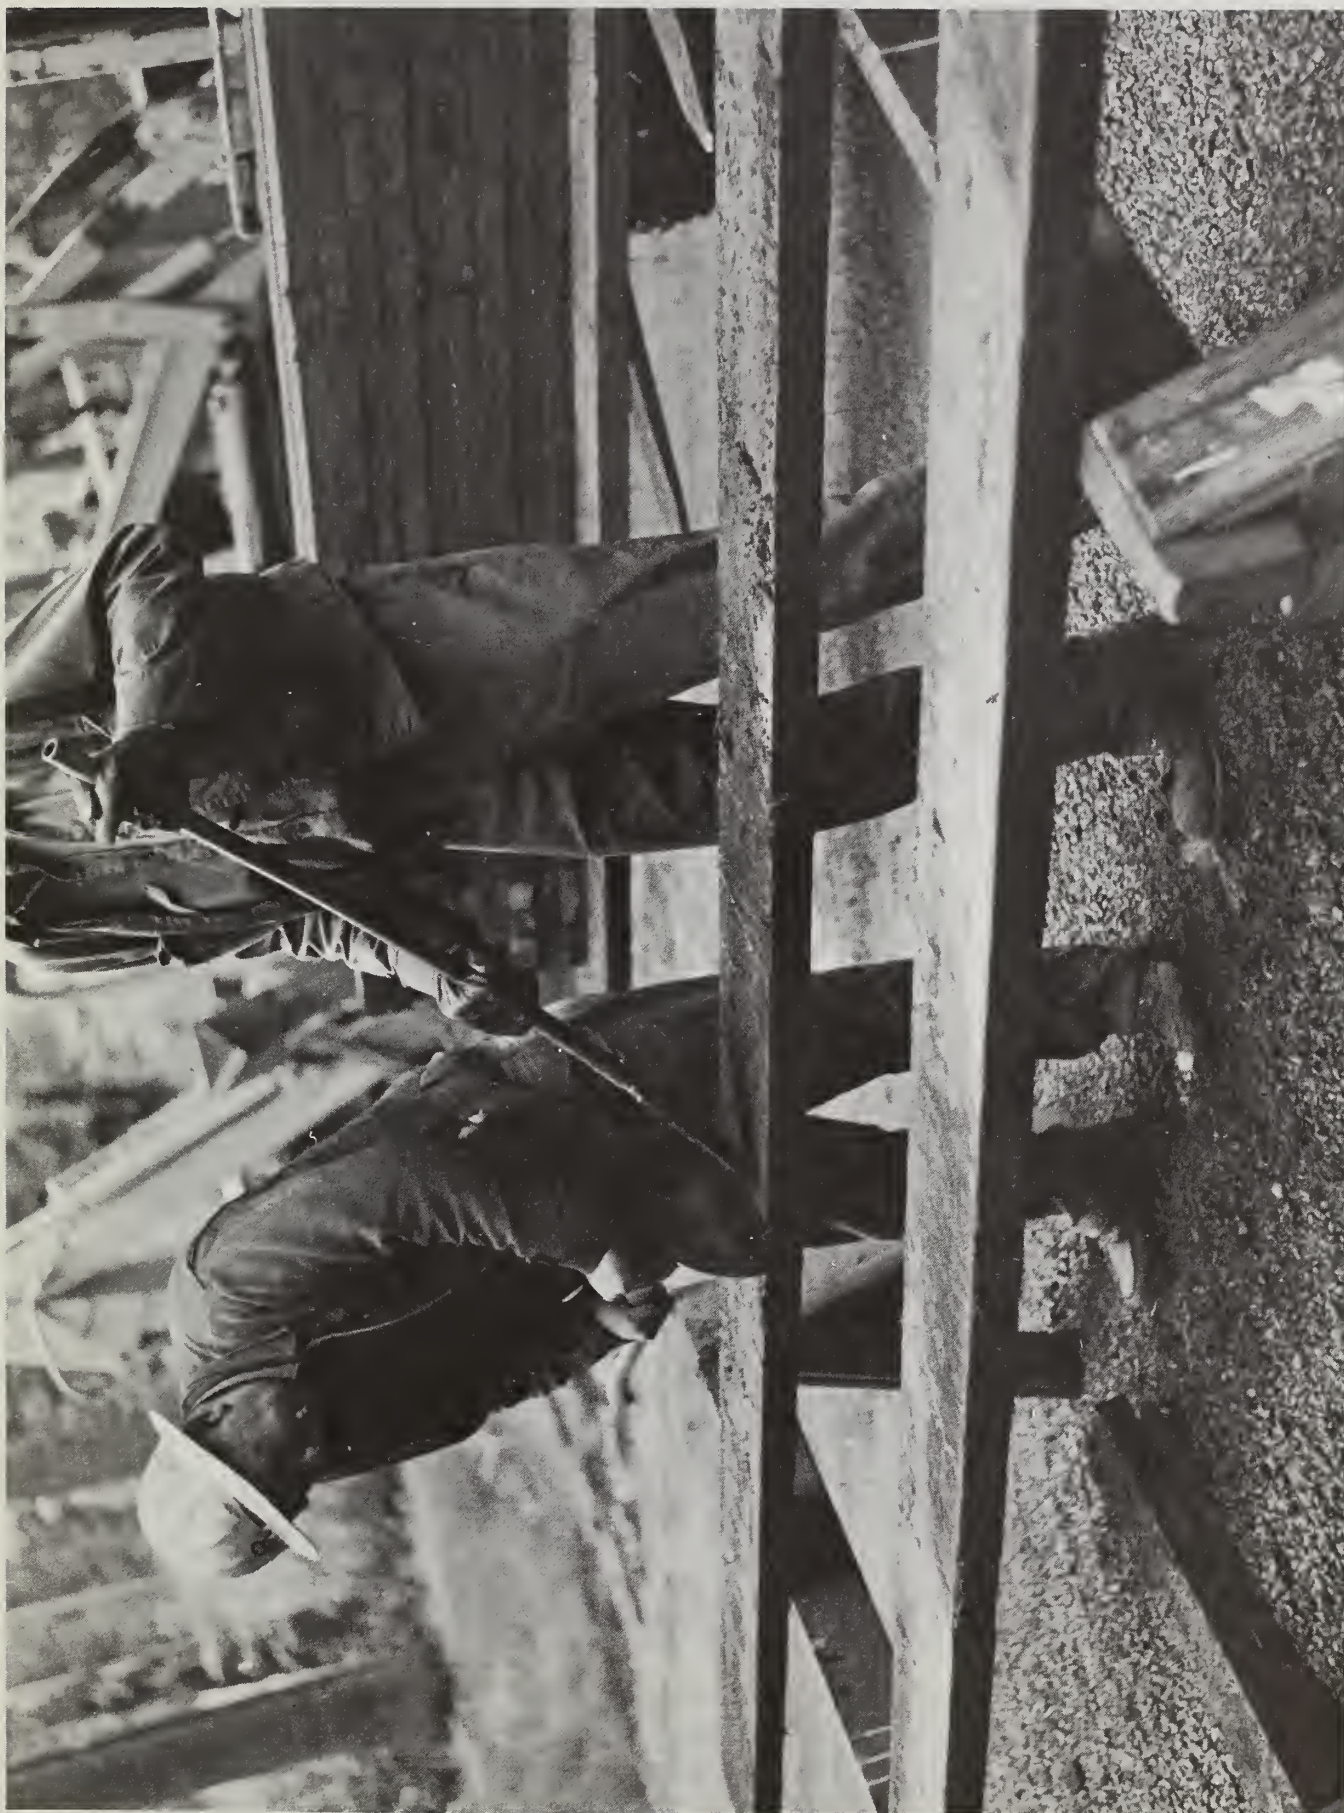
(M 138 110)

Figure 6.--Cleaning the salvaged decking before inspection and selection of boards for redecking one-third of the bridge length was often tedious and time consuming. The workers used both an adze and a steel spud to scrape the soil and creosote from the board surfaces.

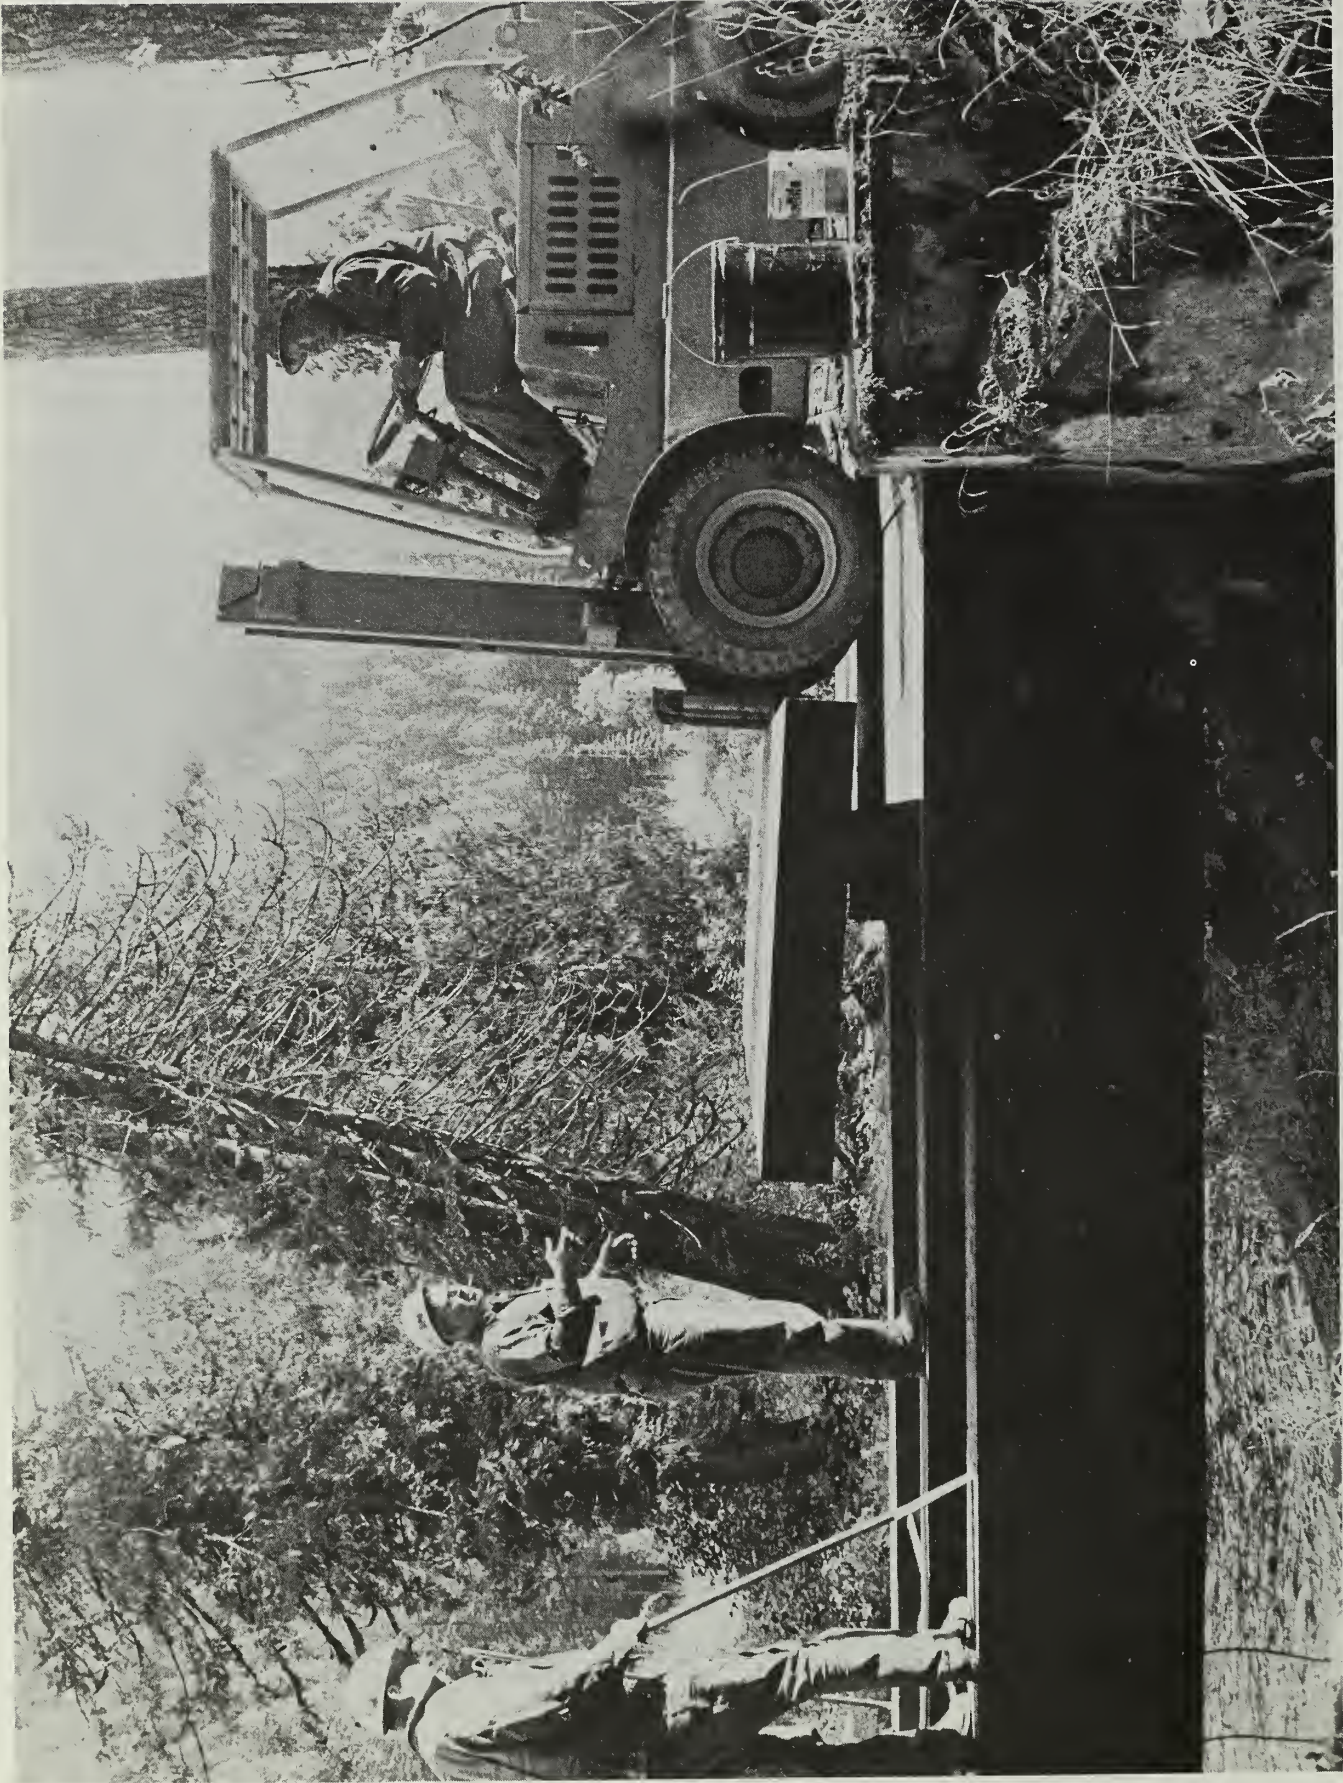
Panel installation began at the southwest end of the bridge and continued over the entire length of that approach span and approximately 5 feet onto the main central span. Figure 17 shows the second 4-foot panel being hauled into position by a small forklift truck. Figure 18 shows the 10-inch-long, 1-inch-diameter steel dowels that were used to transfer vertical shear between panels. Dowels were spaced 7 inches apart.

Figure 17.---Glued-laminated panel being placed on the stringers by the forklift truck.
(M 138 108)

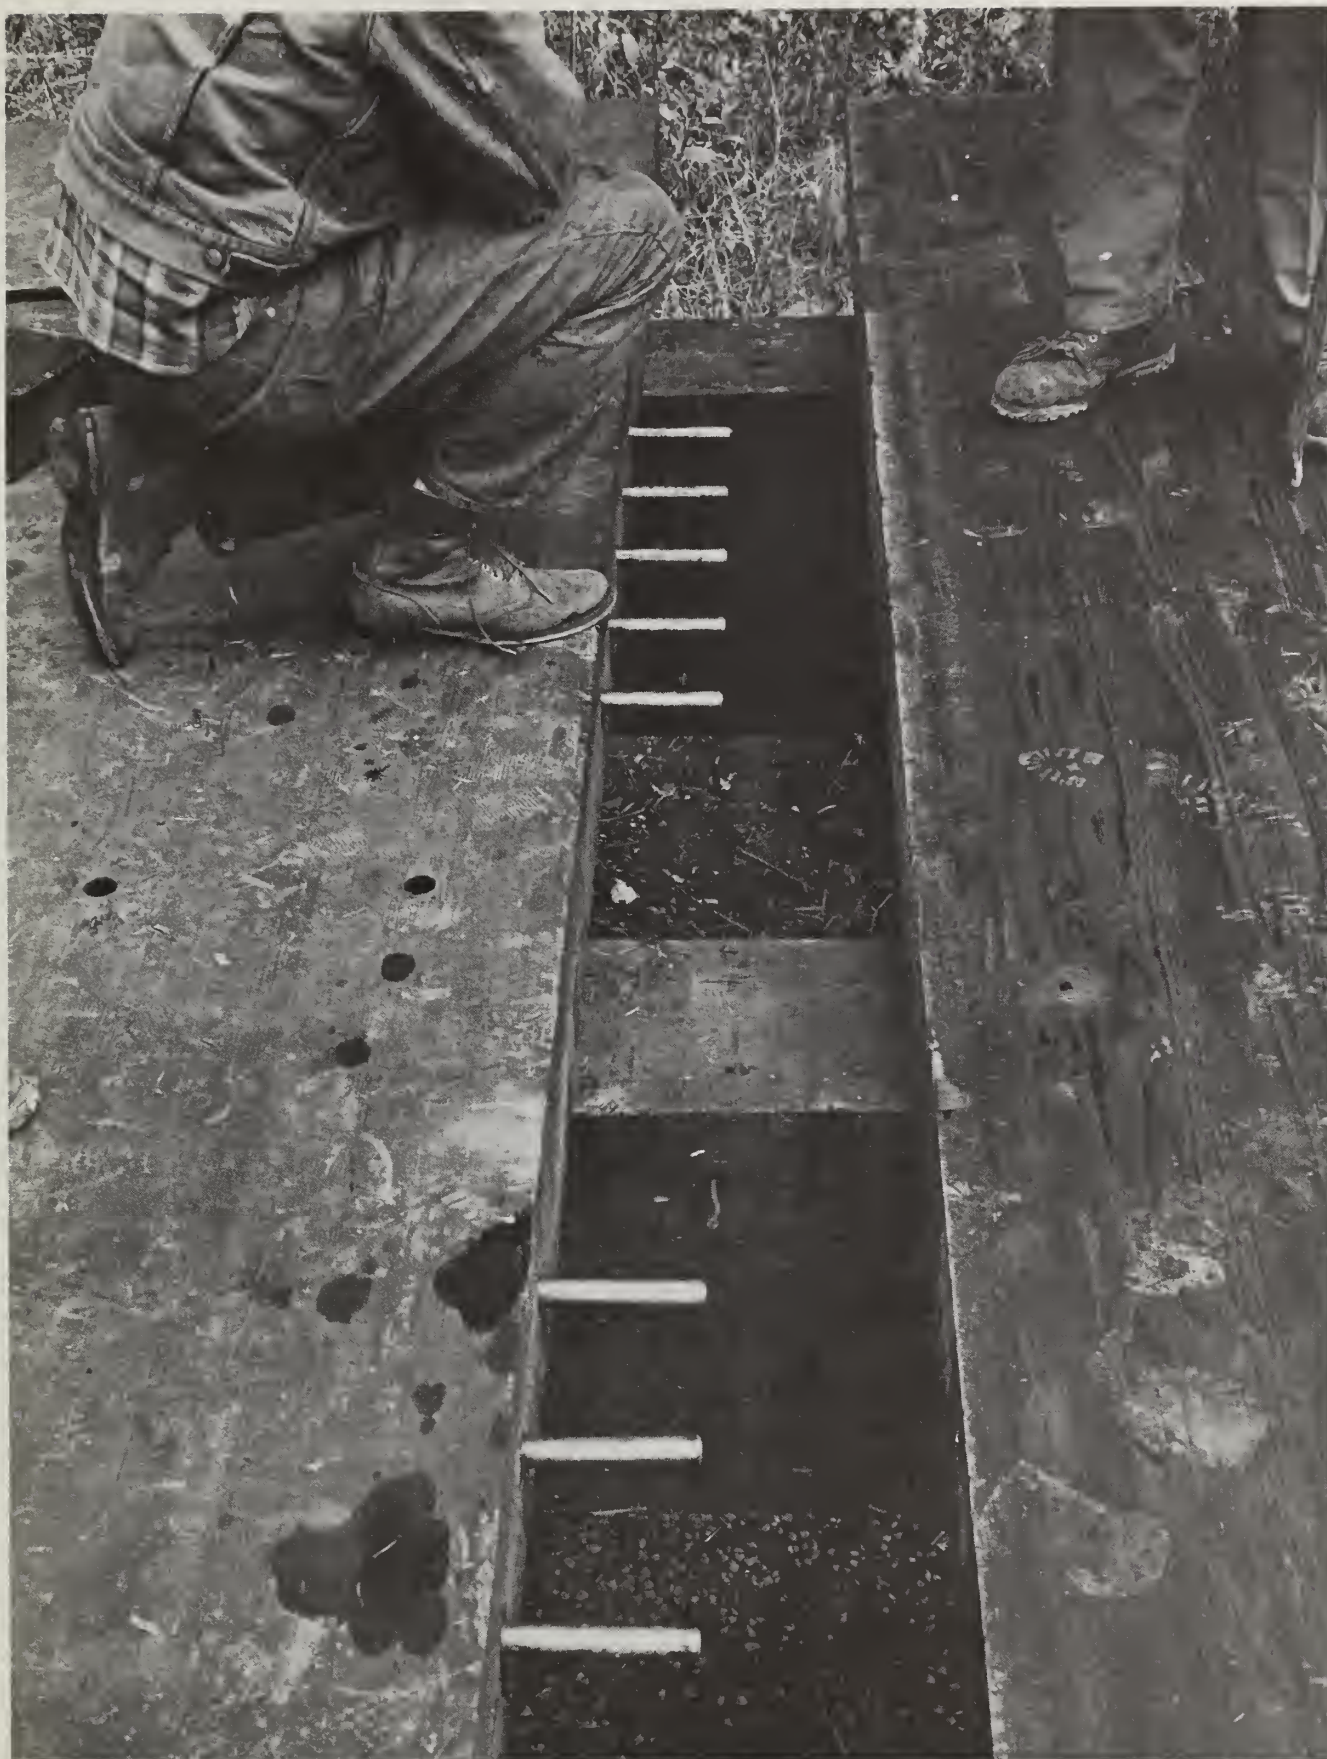
(M 138 115)

Figure 18.--Steel dowels in place in predrilled holes in panel edges.

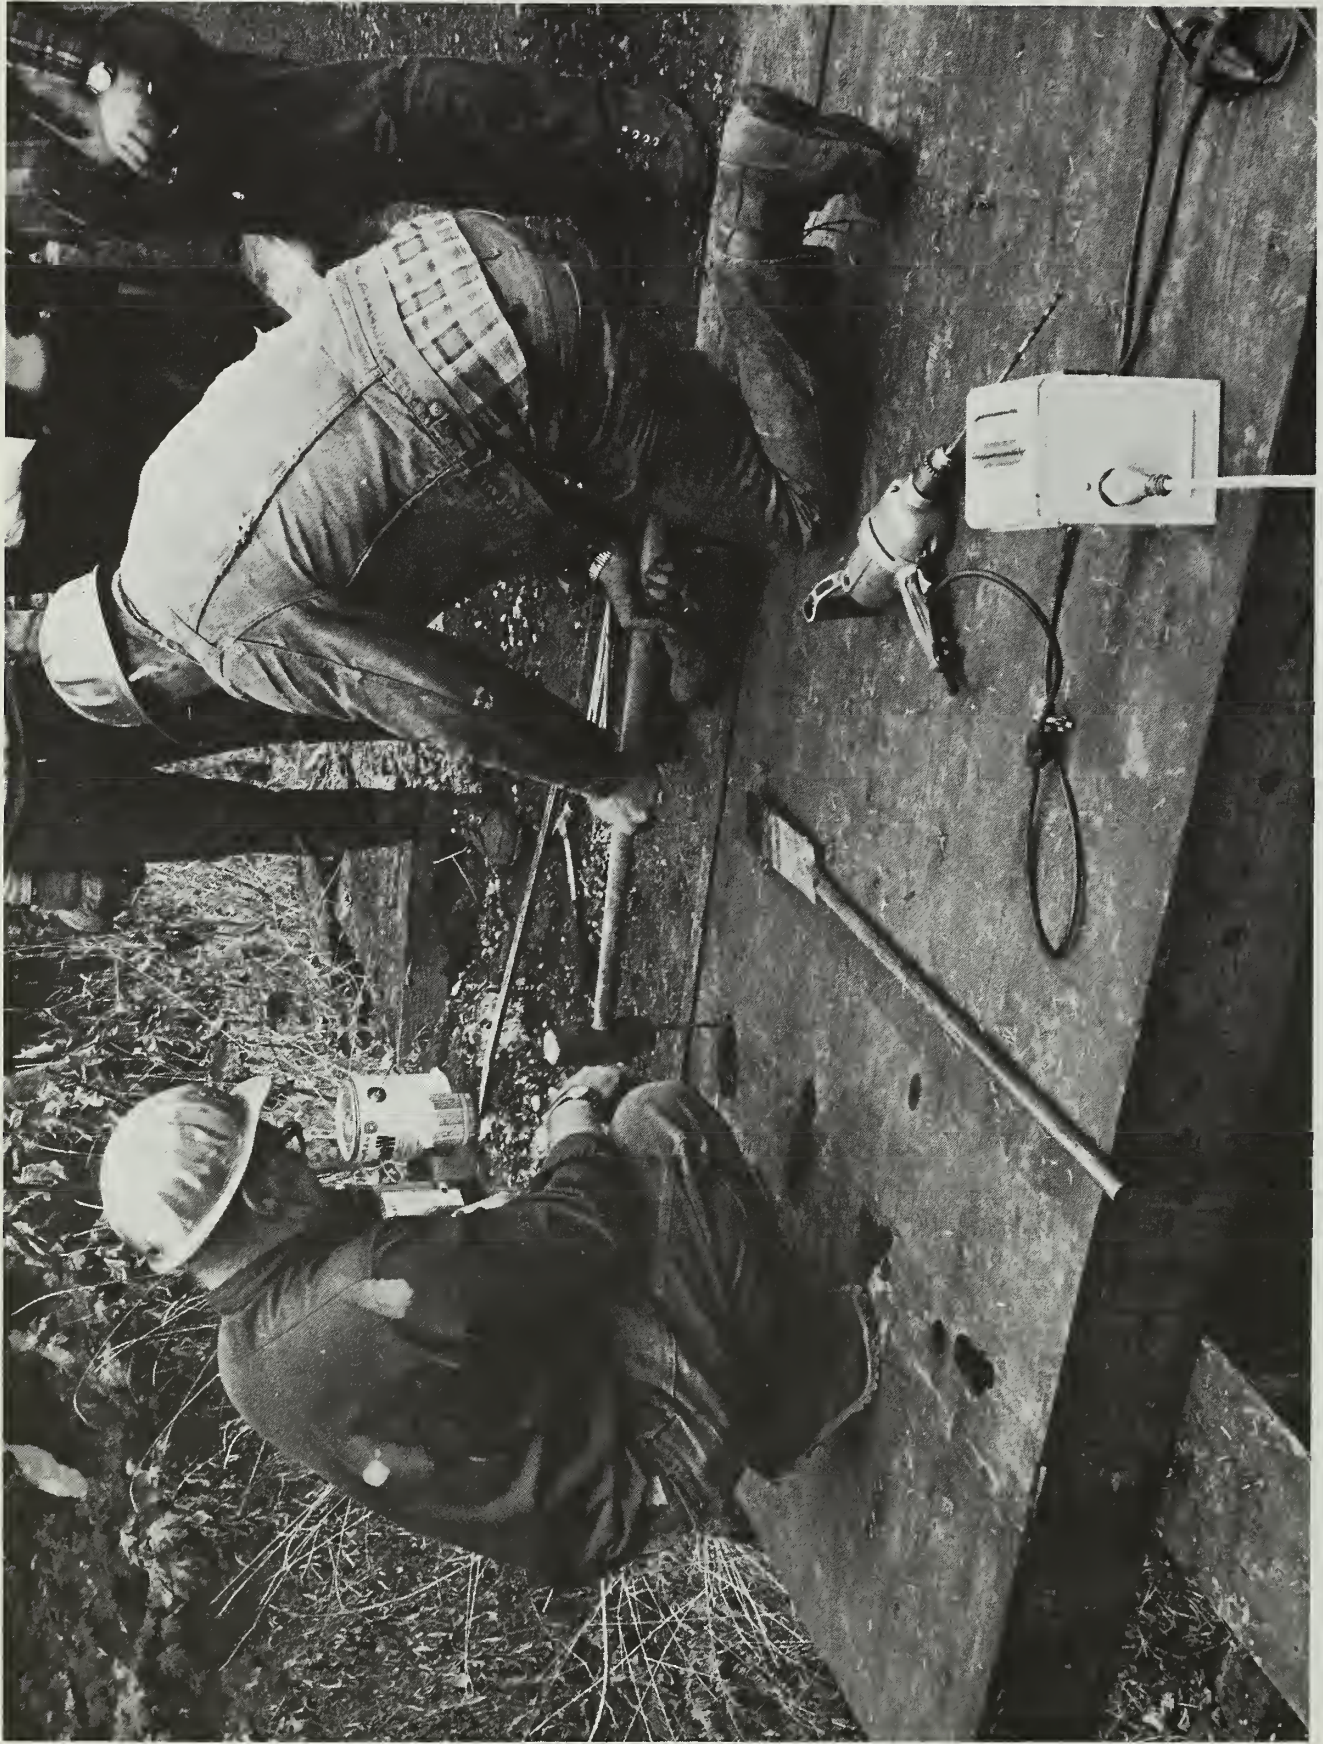
After the panels were drawn into place, half of them were nailed to the stringers with 12-inch-long, 3/8-inch-diameter ring-shank nails. Due to a shortage of these nails, a substitute brand was used on the remaining half of the panels. The substitute nails were the same diameter but were 2 inches shorter than the ring-shank nails and, instead of concentric rings, their penetrating ends were twisted, rectangular sections 3-1/2 inches long. The top 3 inches of each nail hole was 1-1/4 inches in diameter to allow for a steel washer under the head of each nail and for countersinking the washers and nailheads. The nails were driven into field-drilled, field-preservative-treated, 1/4-inch-diameter lead holes in the stringers. Figure 19 shows the nailing on panel No. 1. After the nails had been driven home in the counter bores, a bituminous sealing compound was poured into the finished holes to eliminate water penetration into the nail-hole area.

Figure 19.--Fastening glued-laminated deck panels to stringers with large ring-shank nails.
(M 138 104)
